PRE-PURCHASE BUILDING REPORT

Site Address: 20 Sample Road, Sampleton

Ref No: SG-12-XXXXBR-01

Complies with Australian Standard AS 4349.1 Property Inspections – Part 1 Residential Buildings

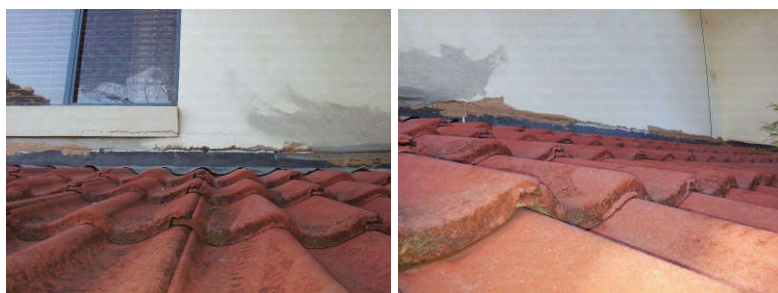
Flashing material is of lead. Flashing is not or does not appear to be correctly set into the brickwork. This can allow water penetration and should be rectified. The potential for water entry is present.

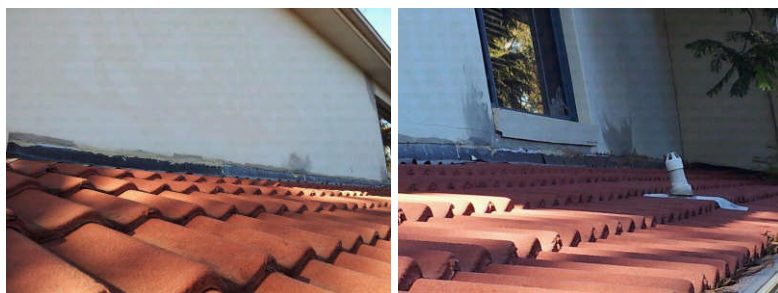
Poor silicone and render failed at this interface.

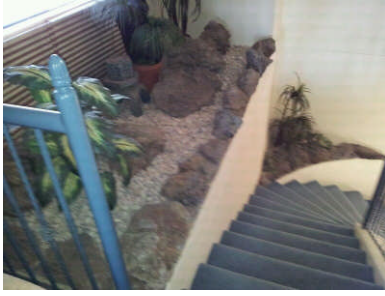
The stairs are constructed primarily from concrete. Safety hazard to occupant falling from accessible area adjacent to staircase, immediate repairs required.

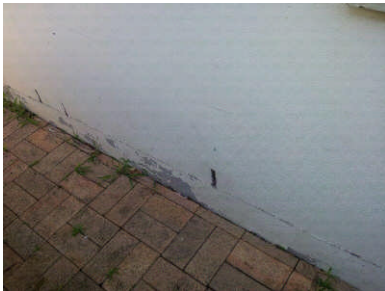
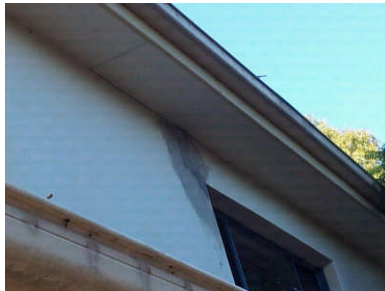
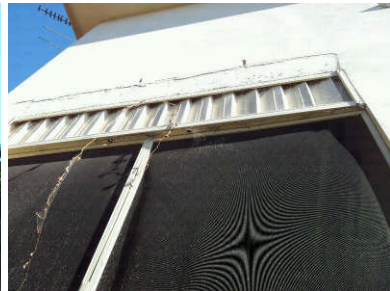
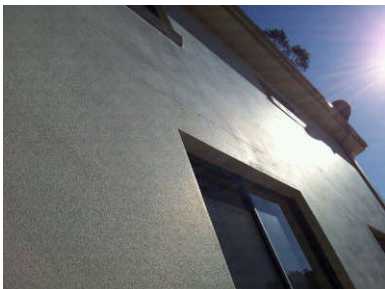
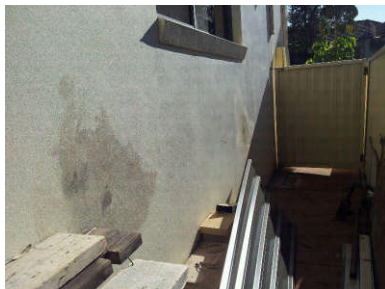
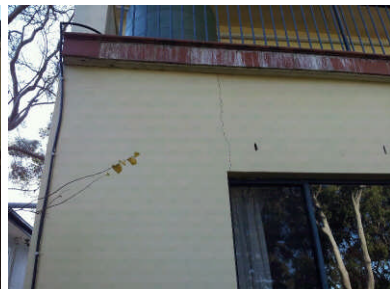
Cracks are evident to brickwork or render. Visible evidence appears moderate. Crack opening width greater than 5.0mm < w < 15.0mm. The area(s) where cracked brickwork or render was noted is listed below.

1. Paint finish below DPC peeling.
2. Excessive amount of render cracking present.
3. Incomplete external work to laundry door head and sides, exposed to weather and damp migration internally.

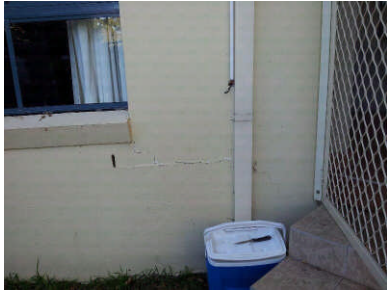
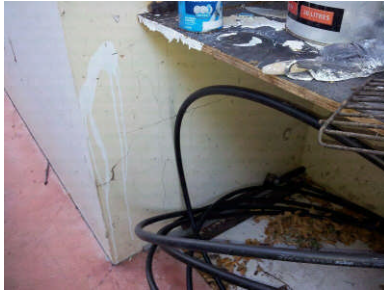
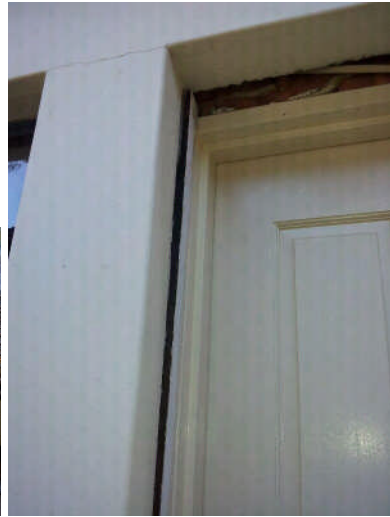
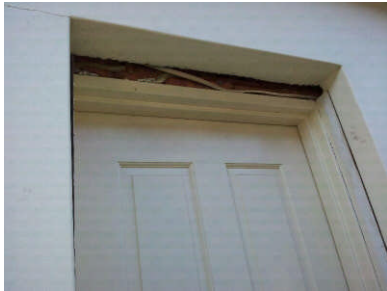
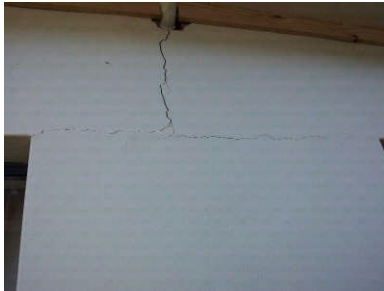
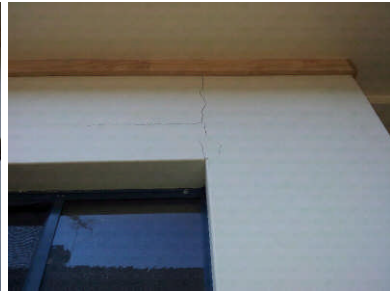
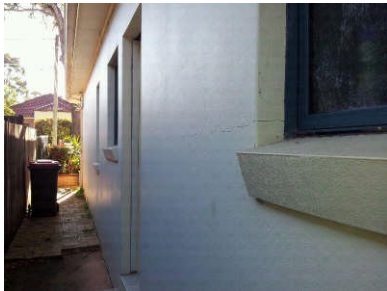
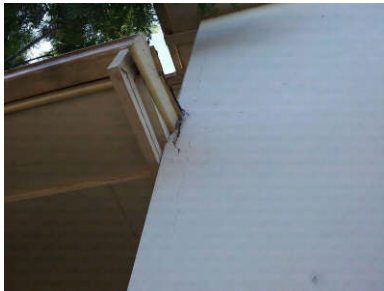
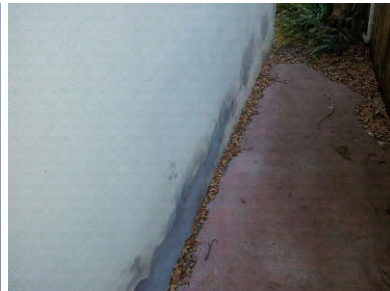
The condition of the walls is generally poor.

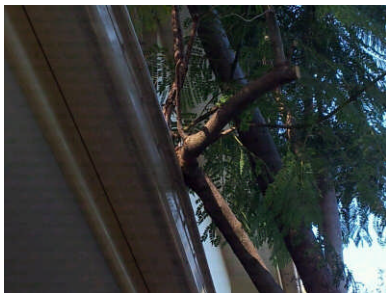
Gutters are damaged or rusting. These should be repaired or replaced as necessary.

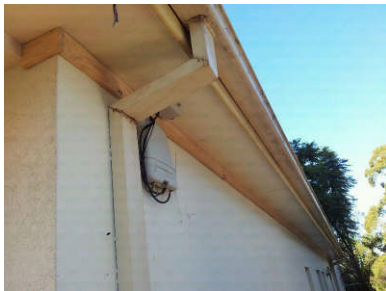
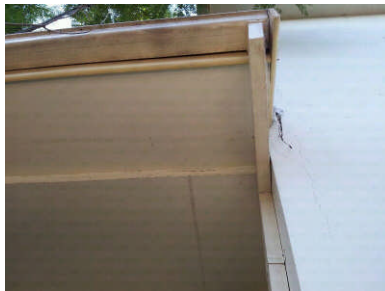
The eaves are lined with fibre cement sheeting. Some eaves linings are sagging and require re fixing. Timber moulding not painted to this elevation.

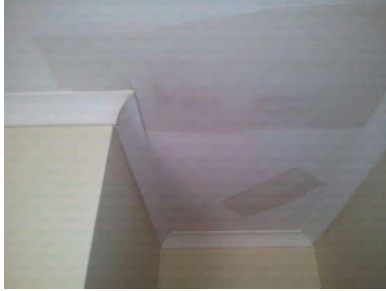
Evidence of patch/repairs present.

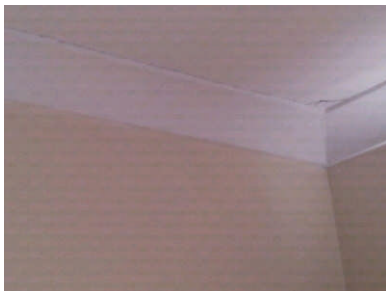
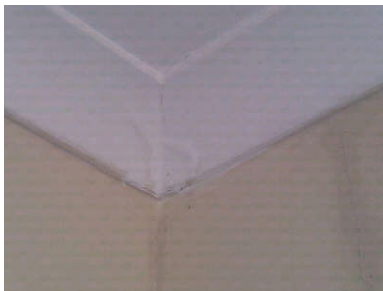
Cornice detaching and cracked and defective.

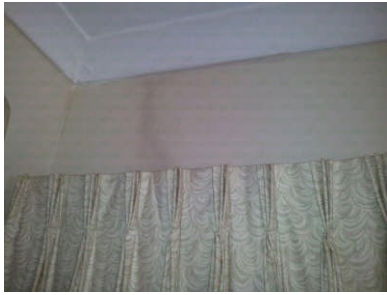
Minor settlement cracks in walls. Crack opening width greater than 1.0mm<w<5.0mm. Periodic maintenance may be required.

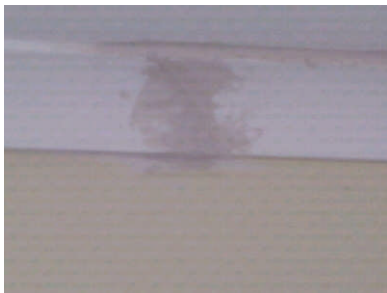
Cornice cracked.

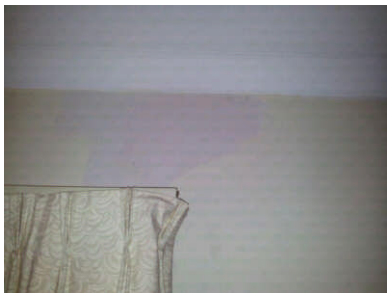
Minor settlement cracks in walls. Crack opening width greater than 1.0mm<w<5.0mm. Periodic maintenance may be required.

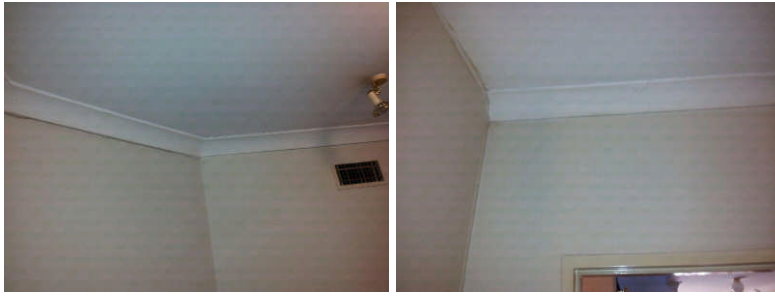
Cornice cracked and detaching from ceiling.

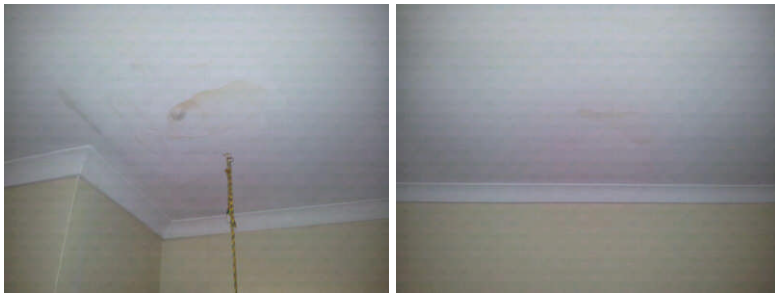
The condition of the ceilings is generally poor. Evidence of past water penetration through ceiling. No evidence of any current leaks.

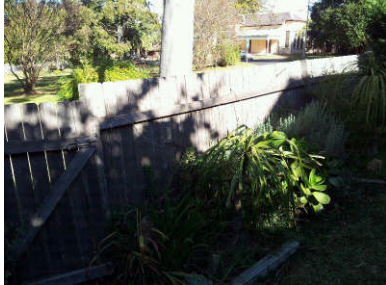
The fences are leaning and repairs are required.

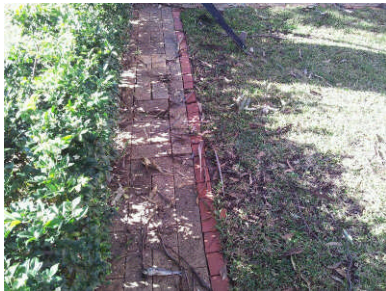
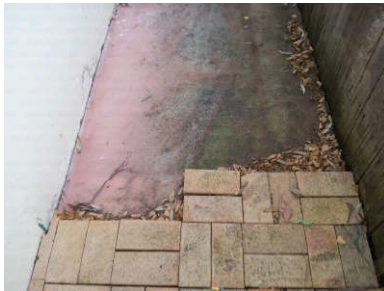
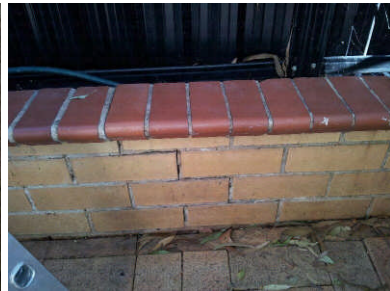
The concrete paths have some visible cracking that should be monitored for further movement.

The paved paths have subsided in areas and will require maintenance. Pavers incomplete to rhs path.

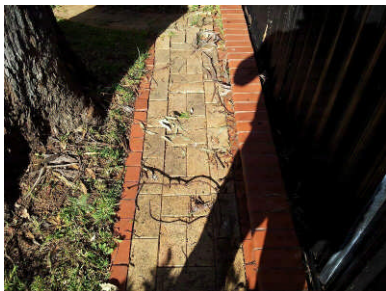
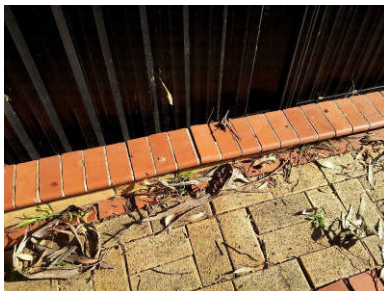
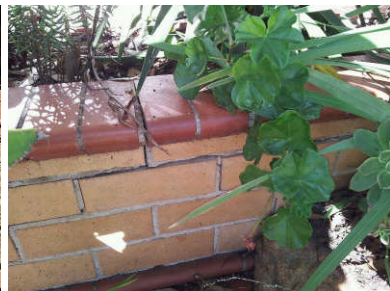
Also perimeter planters and low level masonry walls with tile tops have failed in various locations.

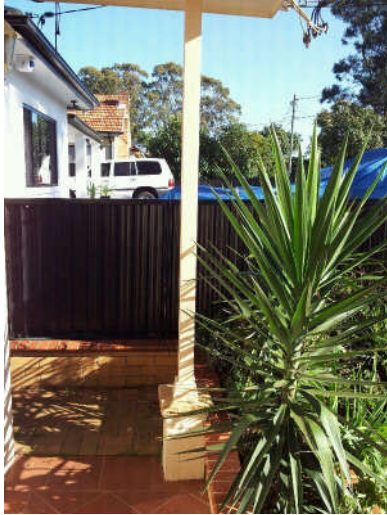
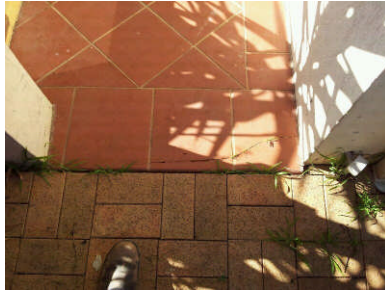
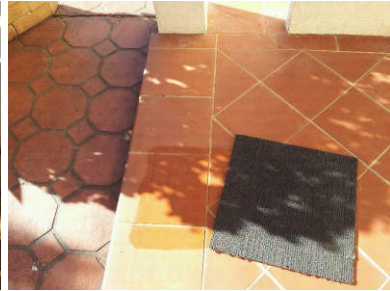
The drummy floor tiles require repair or maintenance. Cracked floor tiles are present and require repair. Timber support post and low pier not plumb or square.

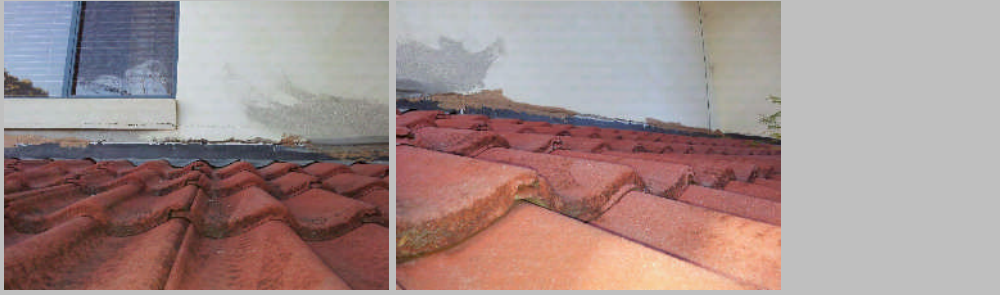
Flashing material is of lead. Flashing is not or does not appear to be correctly set into the brickwork. This can allow water penetration and should be rectified. The potential for water entry is present.

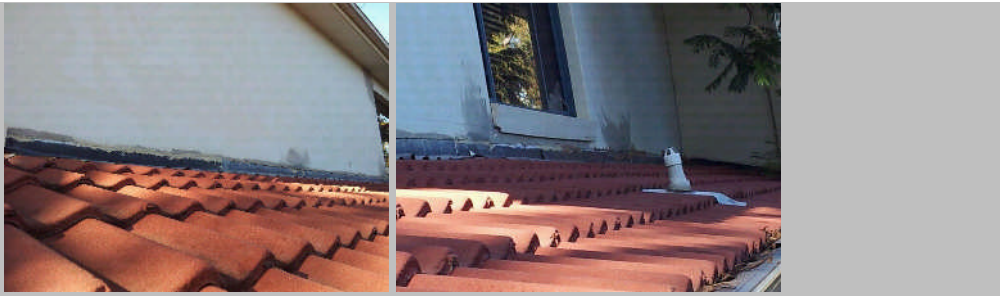
Poor silicone and render failed at this interface.

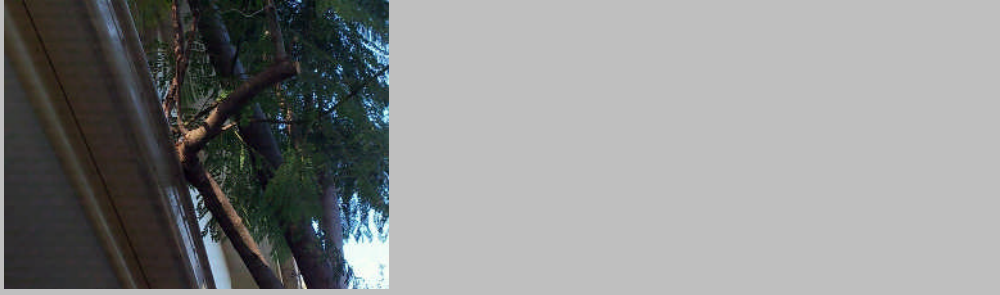
Gutters are damaged or rusting. These should be repaired or replaced as necessary.

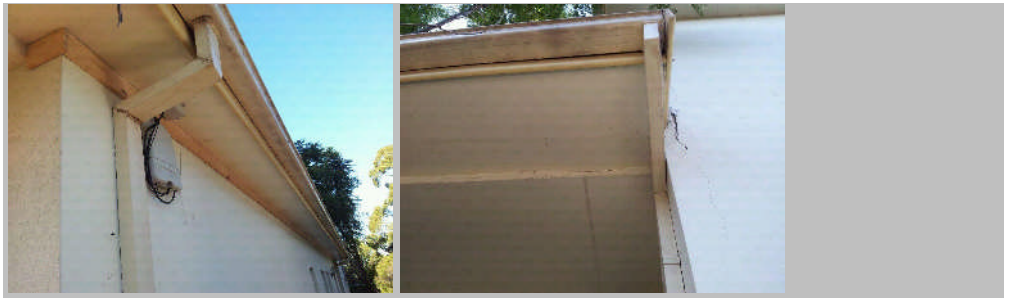
The eaves are lined with fibre cement sheeting. Some eaves linings are sagging and require re fixing. Timber moulding not painted to this elevation.

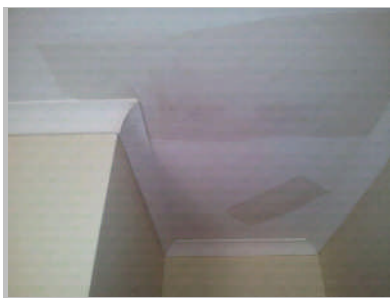
Evidence of patch/repairs present.

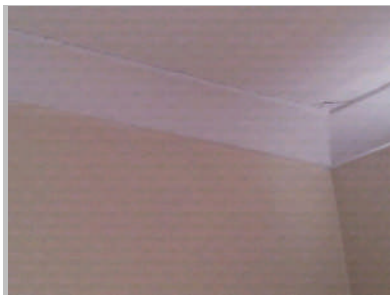
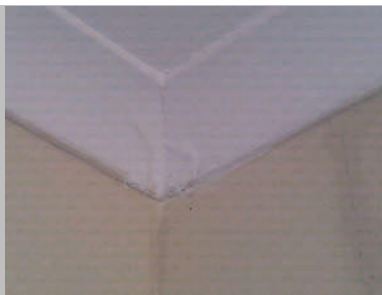
Cornice detaching and cracked and defective.

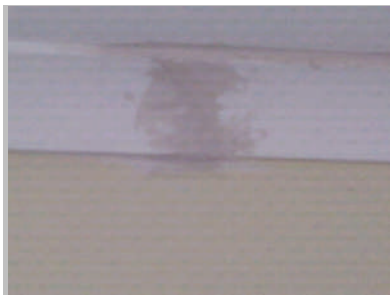
Cornice cracked.

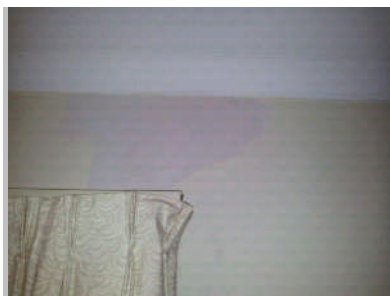
Minor settlement cracks in walls. Crack opening width greater than 1.0mm<w<5.0mm. Periodic maintenance may be required.

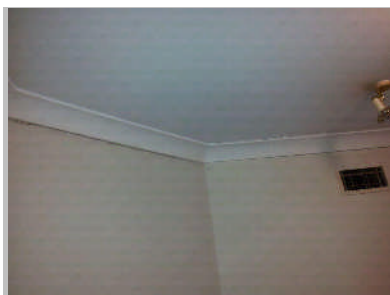
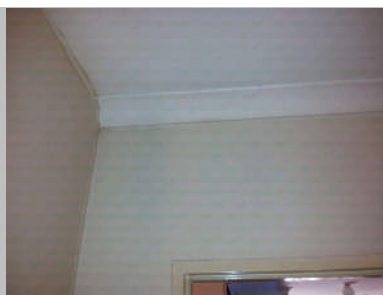
Cornice cracked and detaching from ceiling.

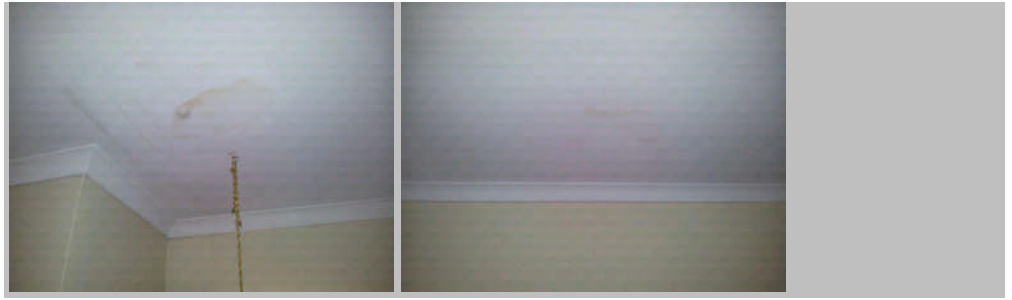
The condition of the ceilings is generally poor. Evidence of past water penetration through ceiling. No evidence of any current leaks.

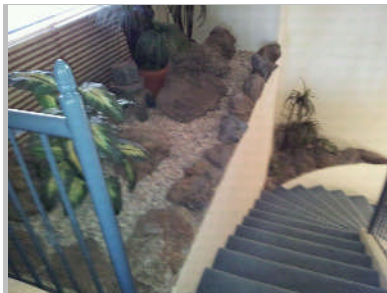
The stairs are constructed primarily from concrete. Safety hazard to occupant falling from accessible area adjacent to staircase, immediate repairs required.

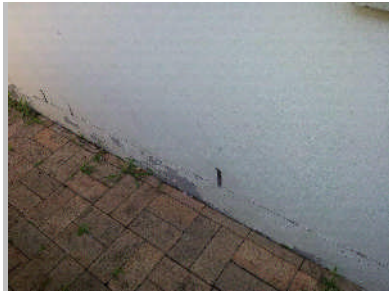
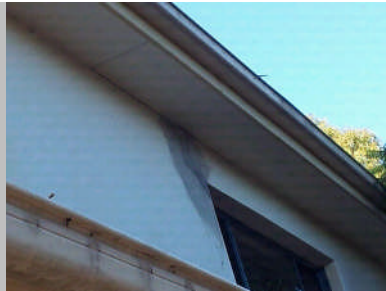
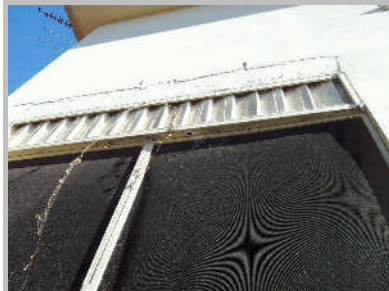
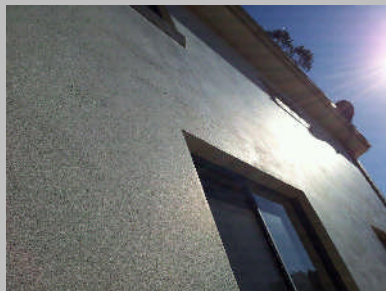
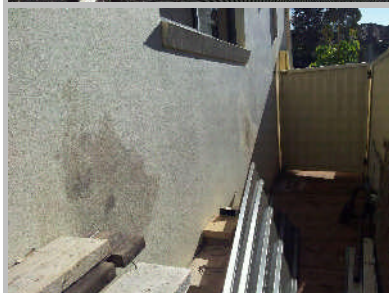
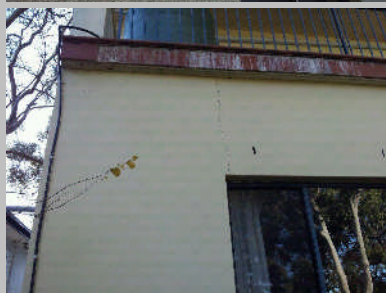
Cracks are evident to brickwork or render. Visible evidence appears moderate. Crack opening width greater than 5.0mm <math>w < 15.0\text{mm}</math>. The area(s) where cracked brickwork or render was noted is listed below.

1. Paint finish below DPC peeling.
2. Excessive amount of render cracking present.
3. Incomplete external work to laundry door head and sides, exposed to weather and damp migration internally.

The condition of the walls is generally poor.

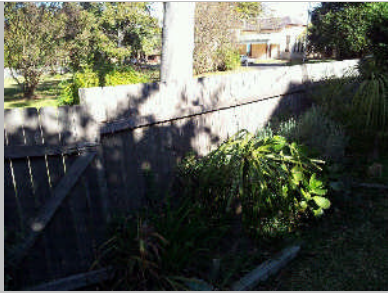
The fences are leaning and repairs are required.

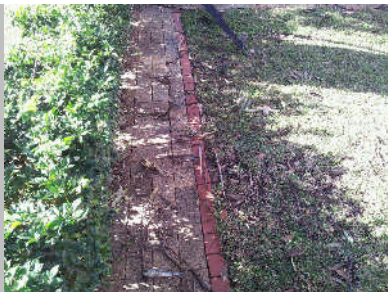
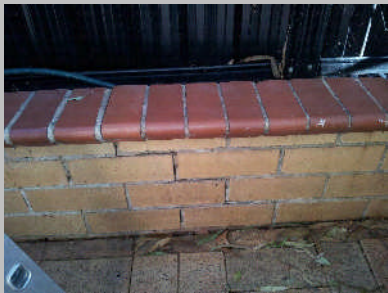
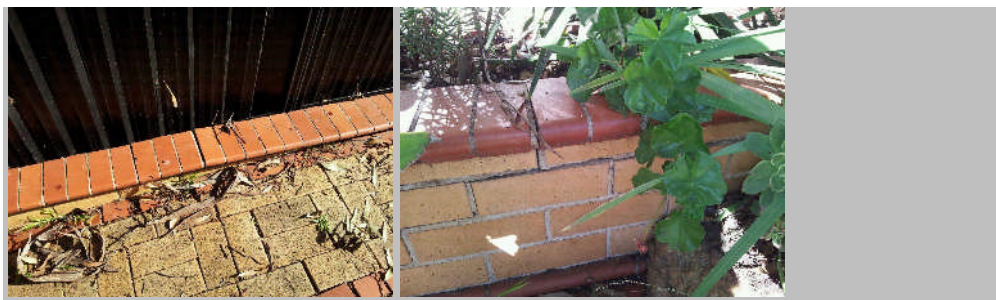
The concrete paths have some visible cracking that should be monitored for further movement.
The paved paths have subsided in areas and will require maintenance. Pavers incomplete to rhs path.
Also perimeter planters and low level masonry walls with tile tops have failed in various locations.

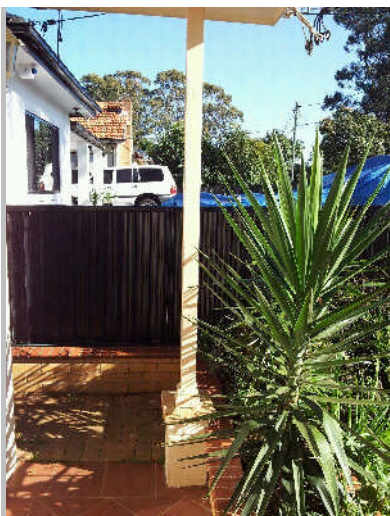
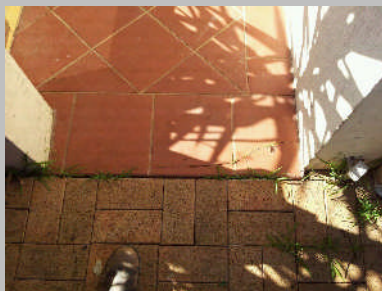
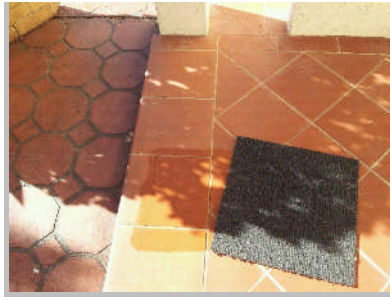
The drummy floor tiles require repair or maintenance. Cracked floor tiles are present and require repair. Timber support post and low pier not plumb or square.
