PRE-PURCHASE BUILDING REPORT

Site Address: 20 Sample Road, Sampleton

Ref No: SG-12-XXXXBR-01

Complies with Australian Standard AS 4349.1 Property Inspections – Part 1 Residential Buildings

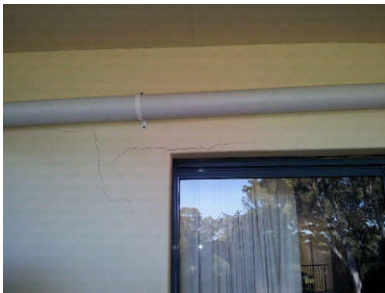
Cracks are evident to brickwork or render. Visible evidence appears moderate. Crack opening width greater than 5.0mm < w < 15.0mm. The area(s) where cracked brickwork or render was noted is listed below.

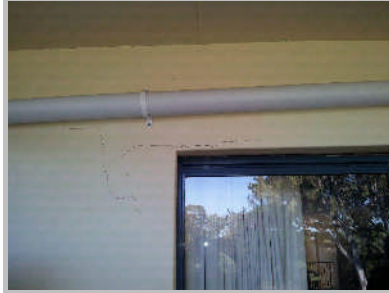
Cracks are evident to brickwork or render. Visible evidence appears moderate. Crack opening width greater than 5.0mm <math>w < 15.0\text{mm}</math>. The area(s) where cracked brickwork or render was noted is listed below.

The condition of the walls is generally poor.

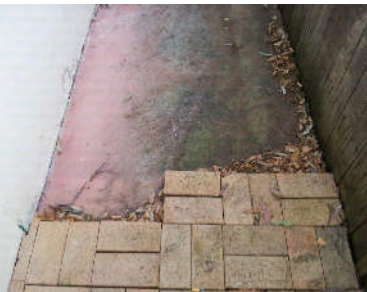
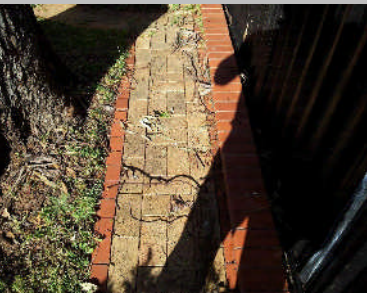
The concrete paths have some visible cracking that should be monitored for further movement.
The paved paths have subsided in areas and will require maintenance. Pavers incomplete to rhs path.
Also perimeter planters and low level masonry walls with tile tops have failed in various locations.
